Technical Report M13

**BANK EROSION STUDY OF THE KASKASKIA RIVER,  
CARLYLE LAKE  
TO NEW ATHENS, ILLINOIS**

Prepared For  
U.S. Army Corps of Engineers  
St. Louis District

February 2000

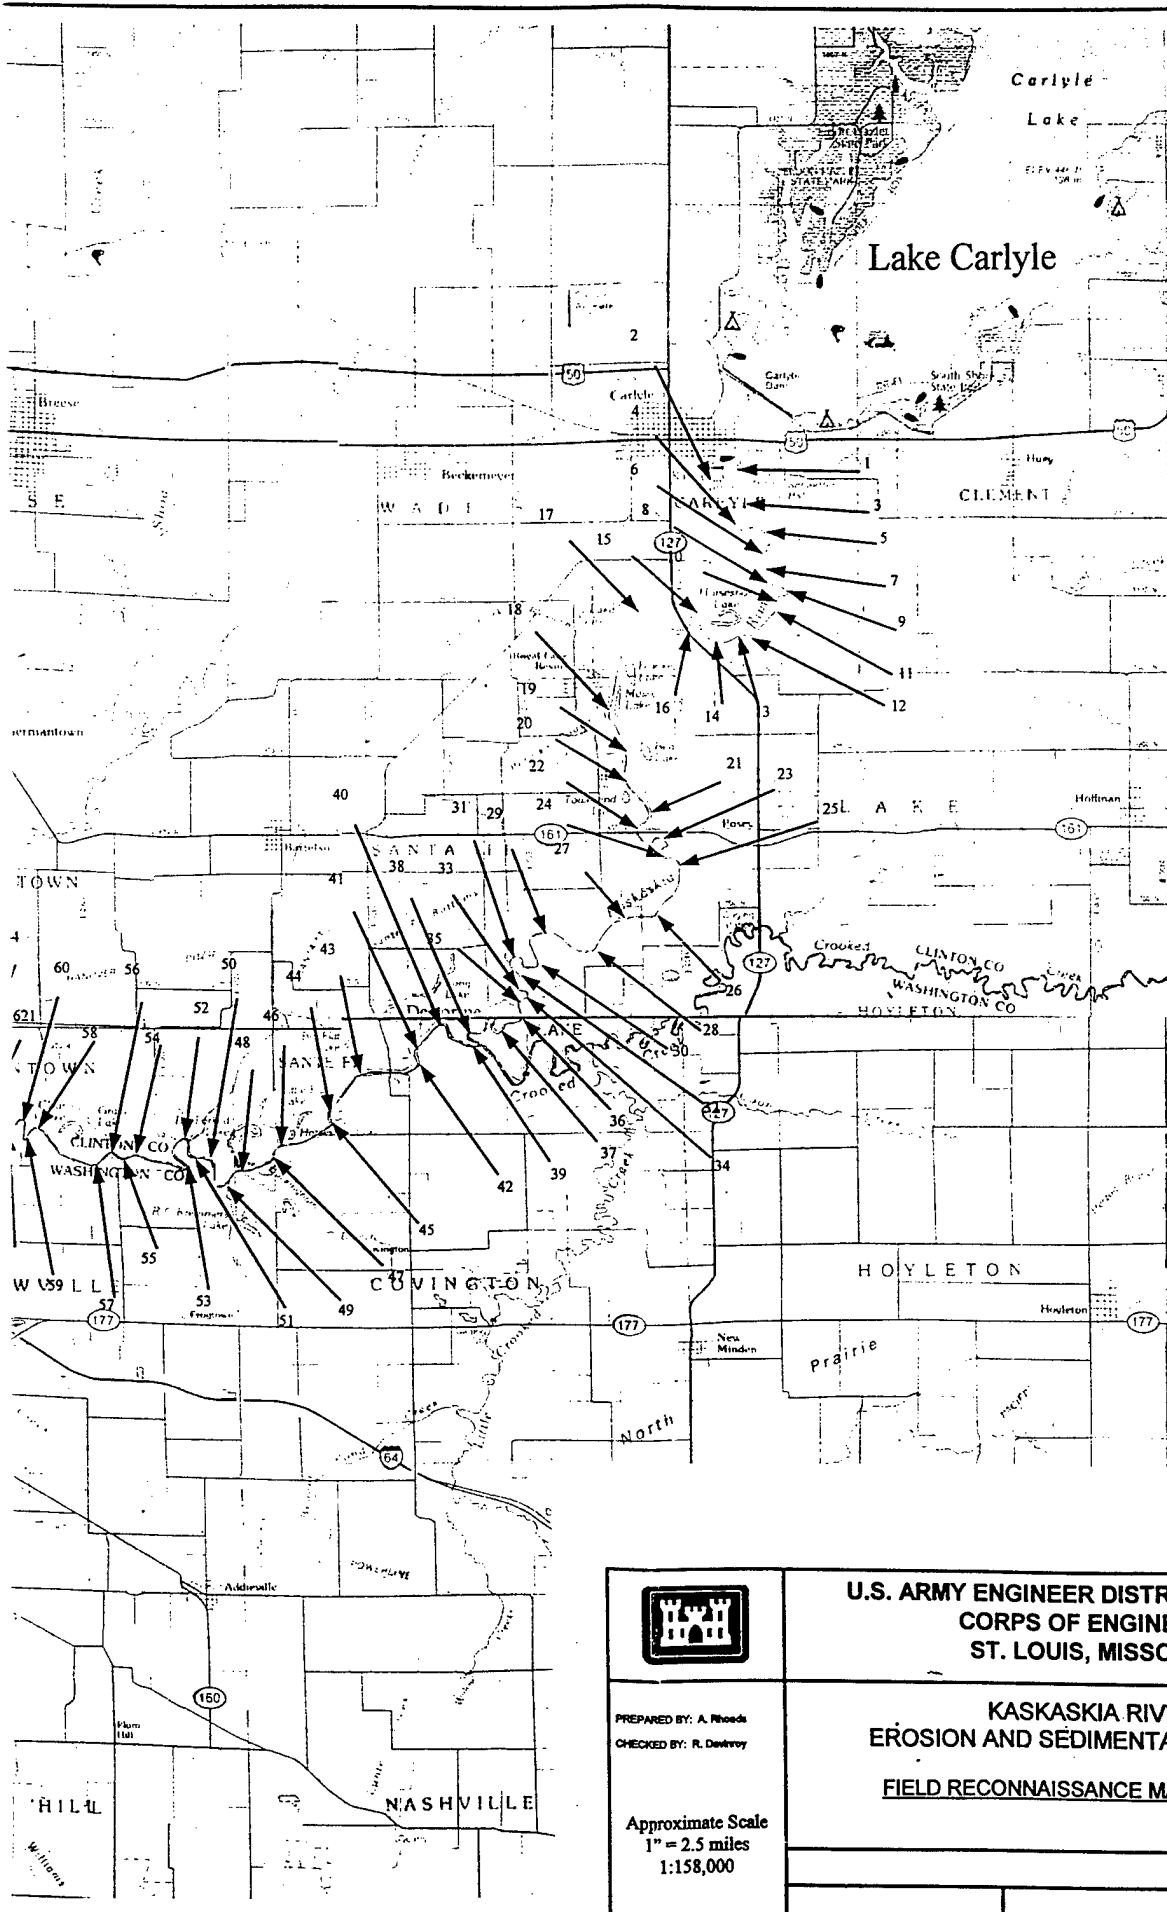
A field reconnaissance map summary was prepared that defined the location of all observed bends within the study reach (Plate 4). The bends were studied during helicopter reconnaissance, conducted on July 7 of 1999, and boat reconnaissance, conducted on July 20 and 21 of 1999. Bend # 1 was located immediately downstream of Carlyle Lake.

It was apparent from field reconnaissance that several of the bends had meandered to a point where permanent cutoffs were most likely to occur in the near future regardless of any remedial measures implemented. These particular areas should be considered in the future, as permanent cutoff development could adversely effect any attempted, nearby bank stabilization works.

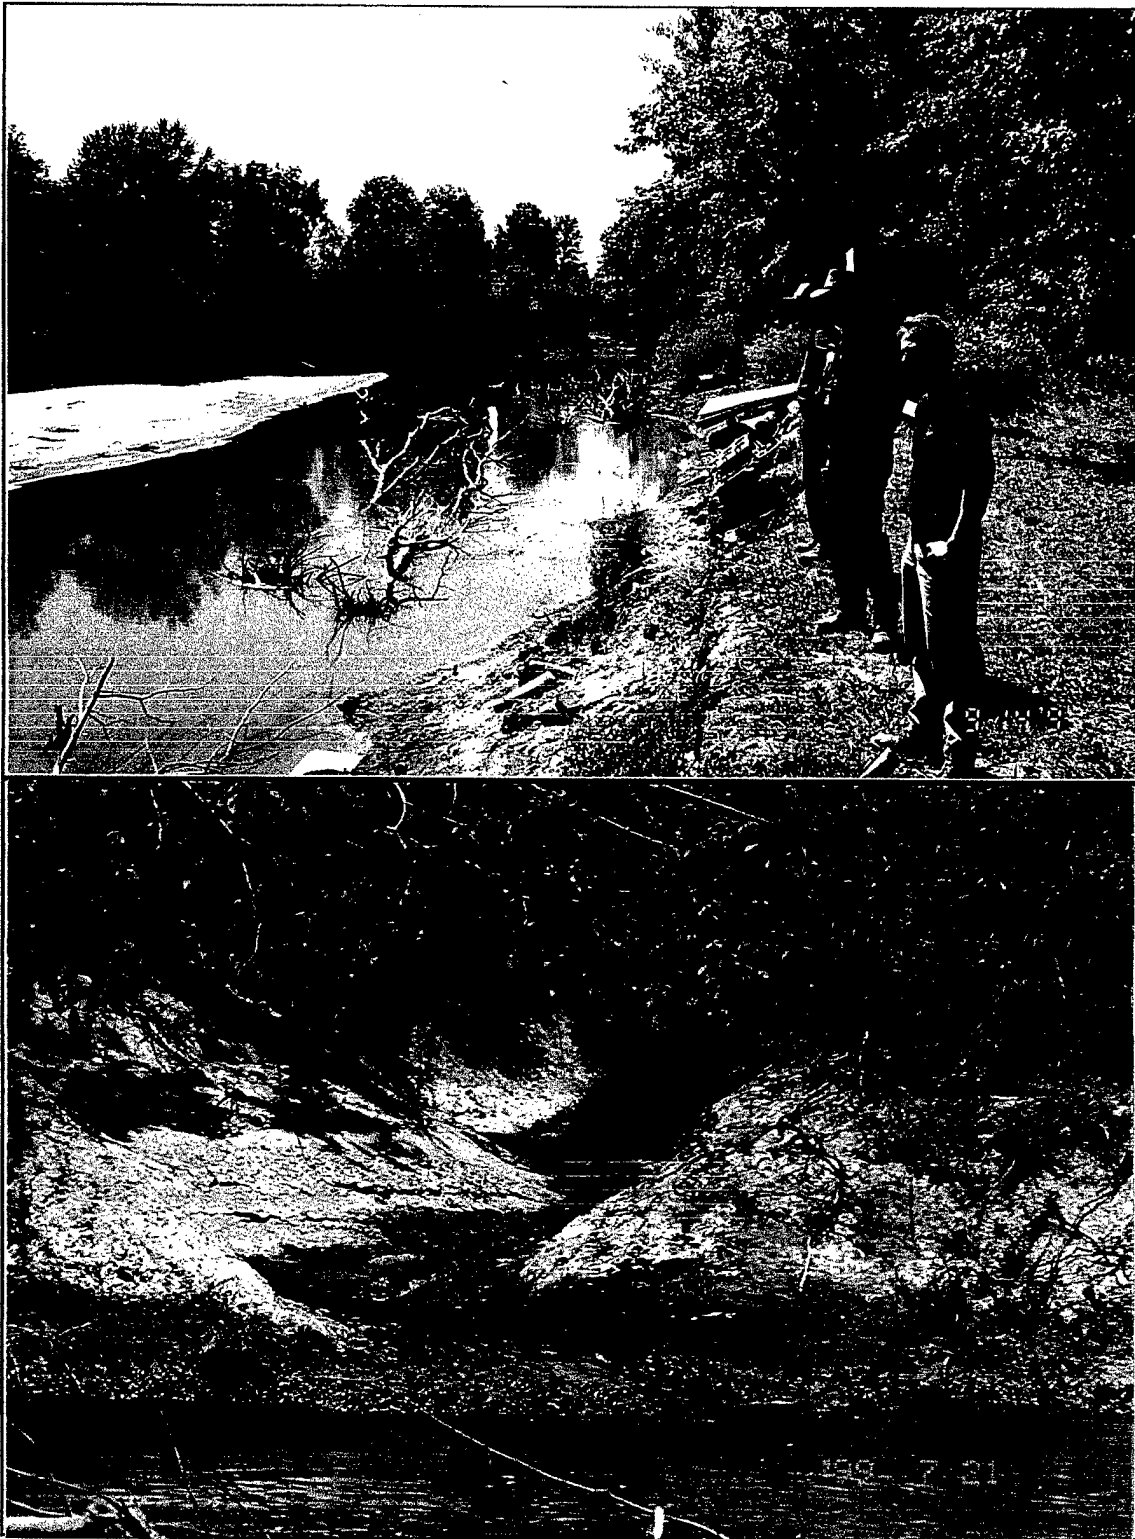
6

The **profile** of the study reach is the most difficult to quantify without accurate survey data. Nonetheless, observations during field reconnaissance clearly indicated that the channel **profile** was still degrading within the lower part of the study reach due to headcutting as a result of the navigation project. The "knickpoint" or upper limit of the headcutting was located near bend #100, approximately 14 river miles above Fayetteville (Plate 6). The volume and density of woody material in the channel increased dramatically below this bend, which corresponded closely with the channel widening and increased bank failure limits noted in the "**dimension**" analysis. In addition, the relative height of the banks increased sharply near bend #100, further indicating channel degradation or headcutting. Upstream of this bend, there was no physical evidence indicative of major degradation of the channel. Plates 7 and 8 are reconnaissance photos illustrating typical effects of the headcutting observed on the Kaskaskia River.

Top Photo: Excessive vegetative debris lining the river channel indicates increased bankline erosion.

Bottom Photo: Perched tributary indicates a lowering or scouring of the channel profile.

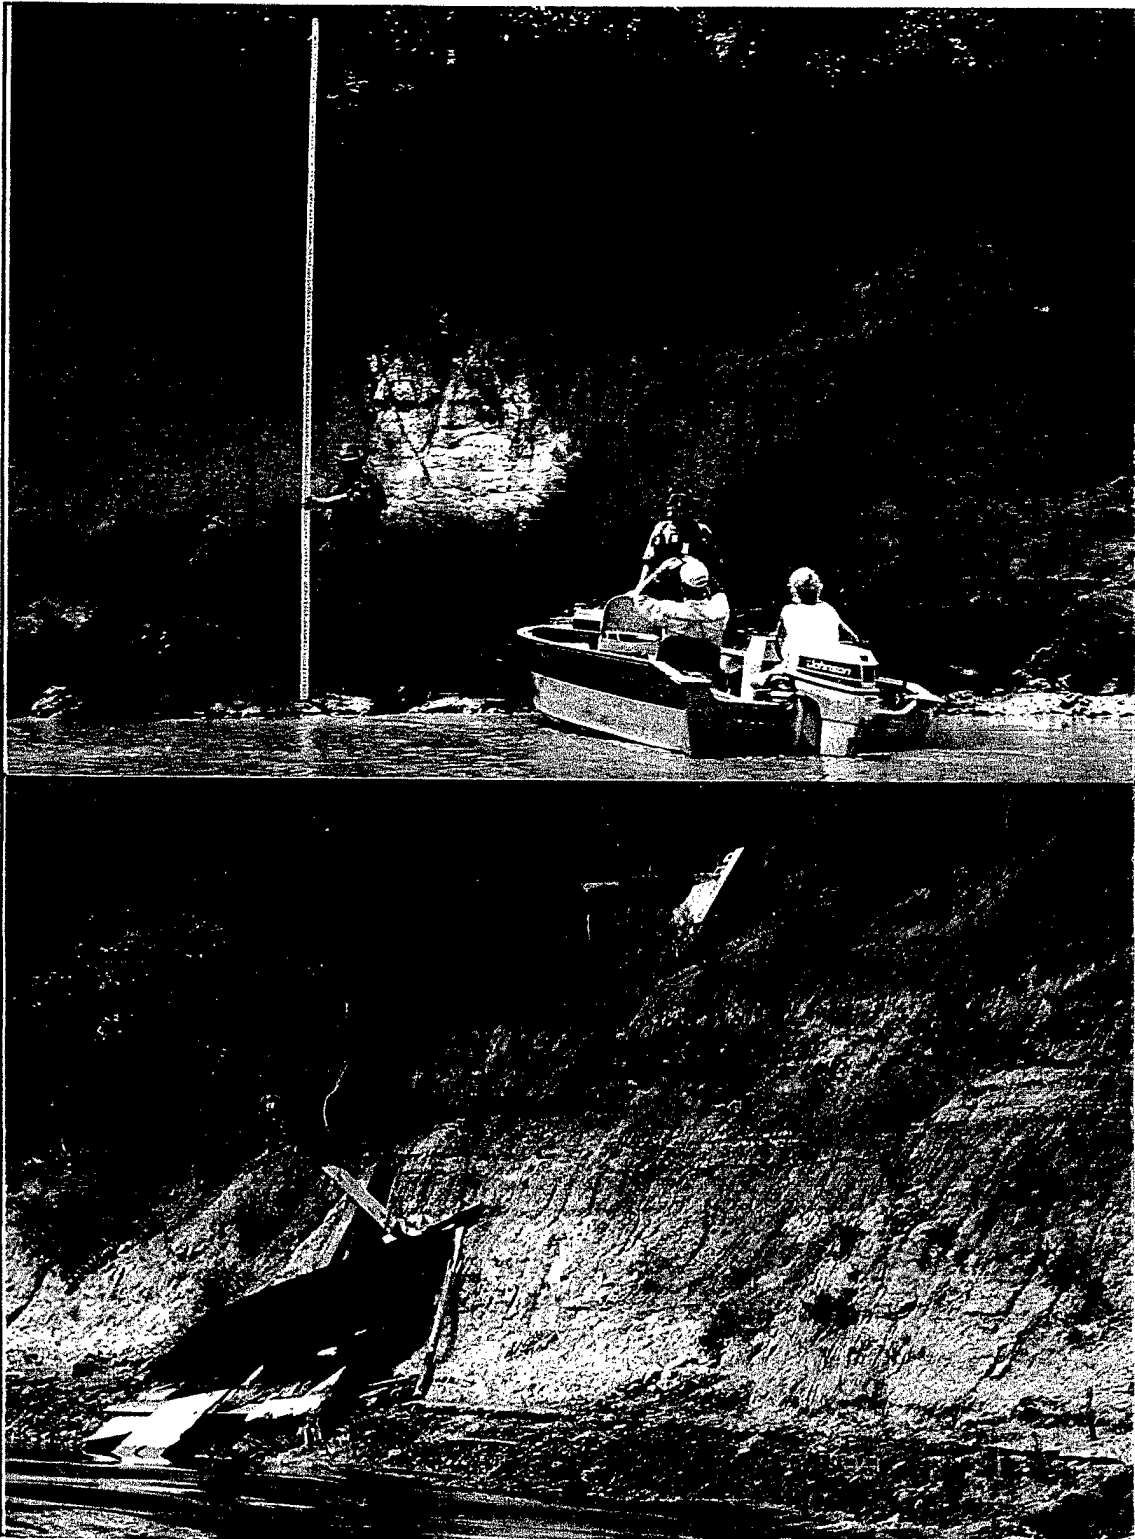
7

**Top Photo:** Banklines have eroded excessively to become unnaturally high and steep with little vegetation.

**Bottom Photo:** Excessive bankline erosion has caused increased property loss
